# FIELD STUDY ABOUT THE IMPACT OF ELECTROCUTION IN THE EGYPTIAN VULTURE BREEDING TERRITORIES IN ALBANIA

**Protection and Preservation of Natural Environment in Albania (PPNEA)  
2019**

This survey has been realized by the center for Protection and Preservation of Natural Environment in Albania (PPNEA) within the frame of the project “Egyptian Vulture New Life” with project code LIFE16 NAT/BG/00874.

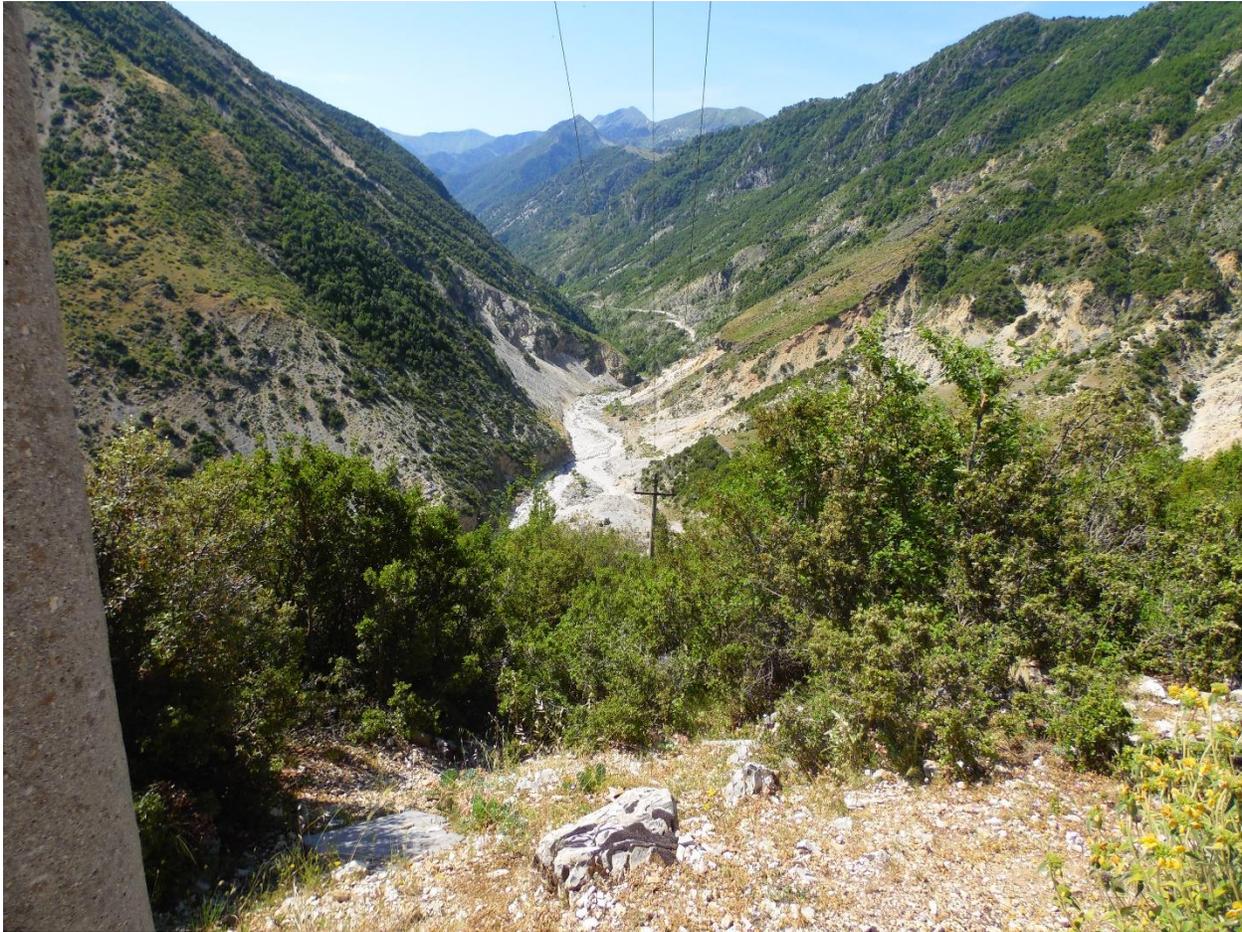
A considerable part of the power line pylons were placed in dense shrubby vegetation, and steep terrain where the observation access was impossible. Therefore the observation in these parts of the transect has not been performed. Please see figure 3 and 4 below.

Figure 3: Power line transect situated in dense shrubby vegetation and steep terrain.

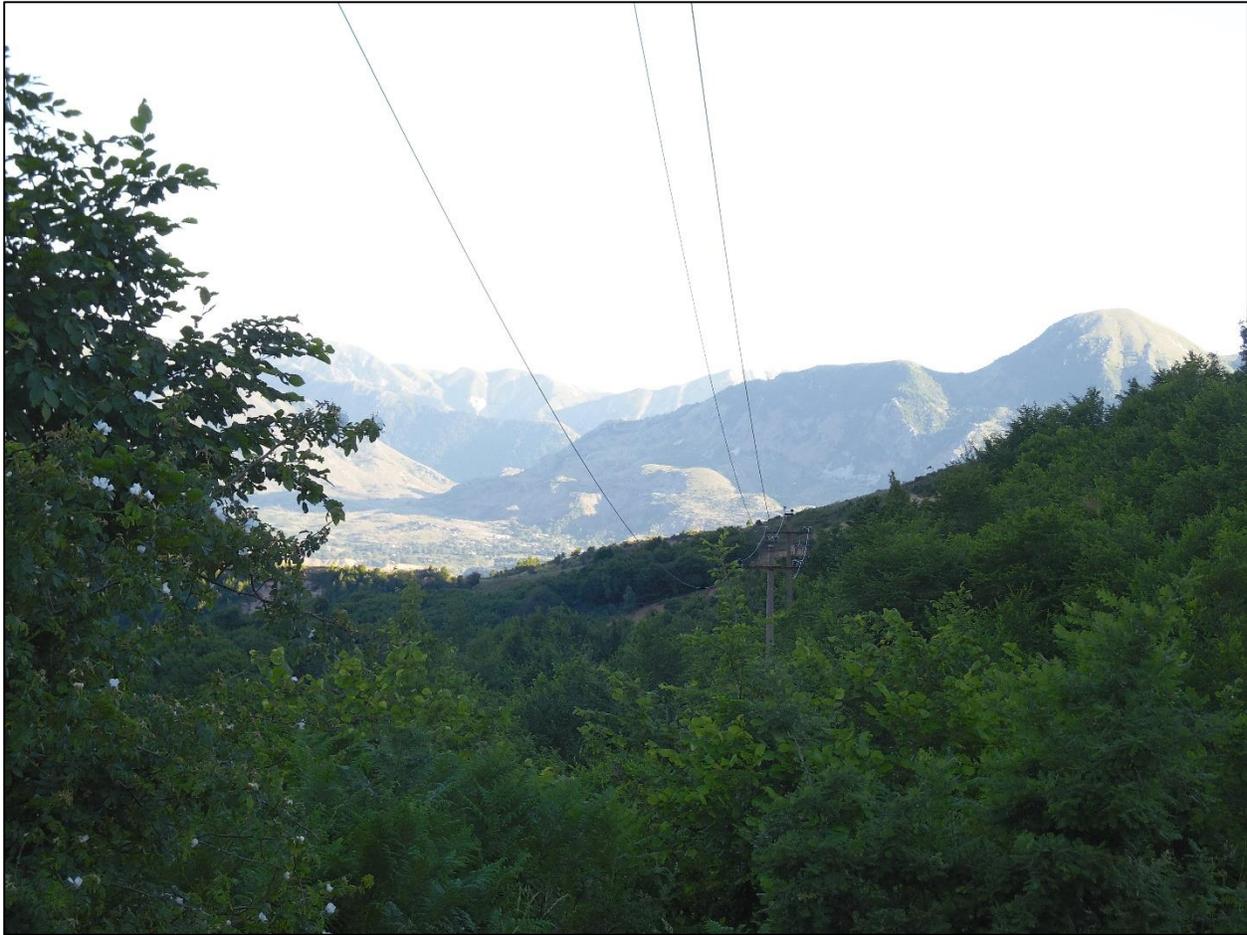
Figure 4: Power line transect situated in dense shrubby vegetation terrain.

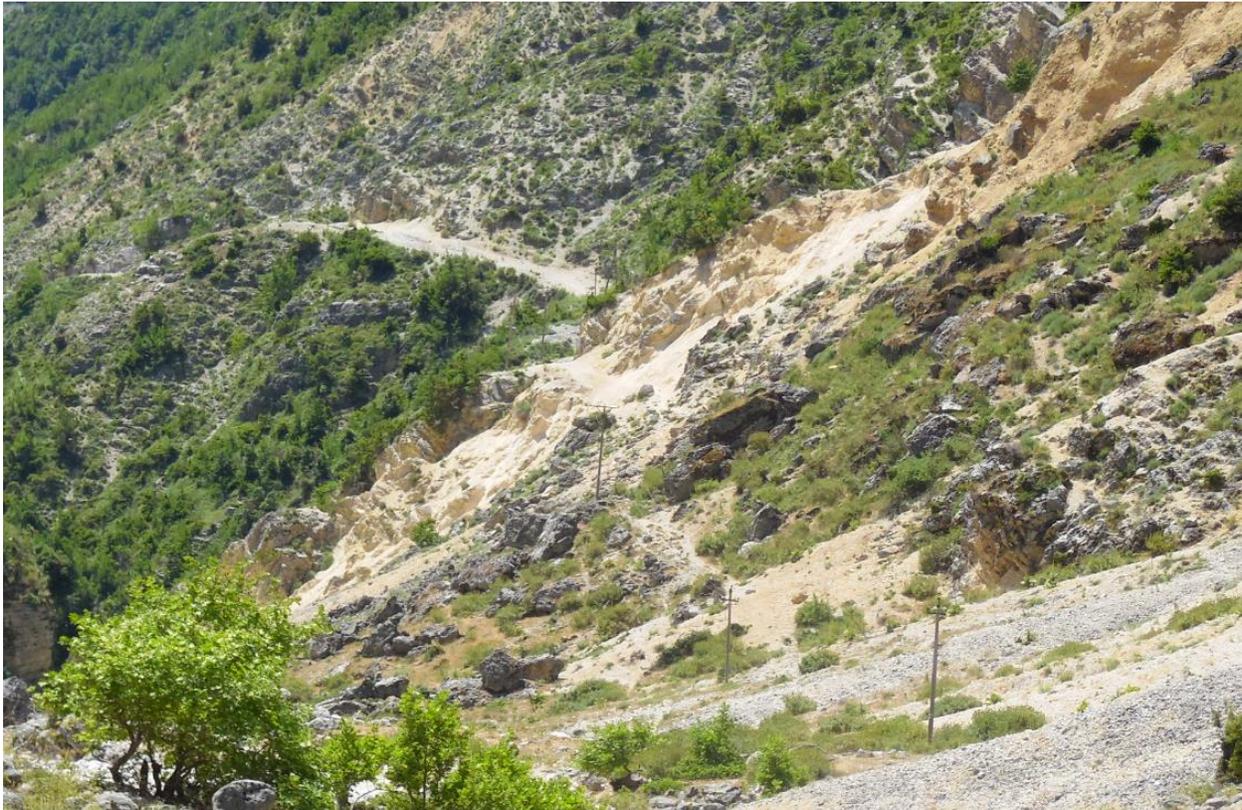
The rest of the transect is situated in open area (please see fig 5 and 6 below) where surveying is possible and easy to carry out.

Moreover, pylons are of medium voltage and constructed in such way that would be very dangerous for birds of prey if used for perching, as the wires are situated closed to each other that easily enable contact even for falcons.

Figure 5: Power line transect situated open area.

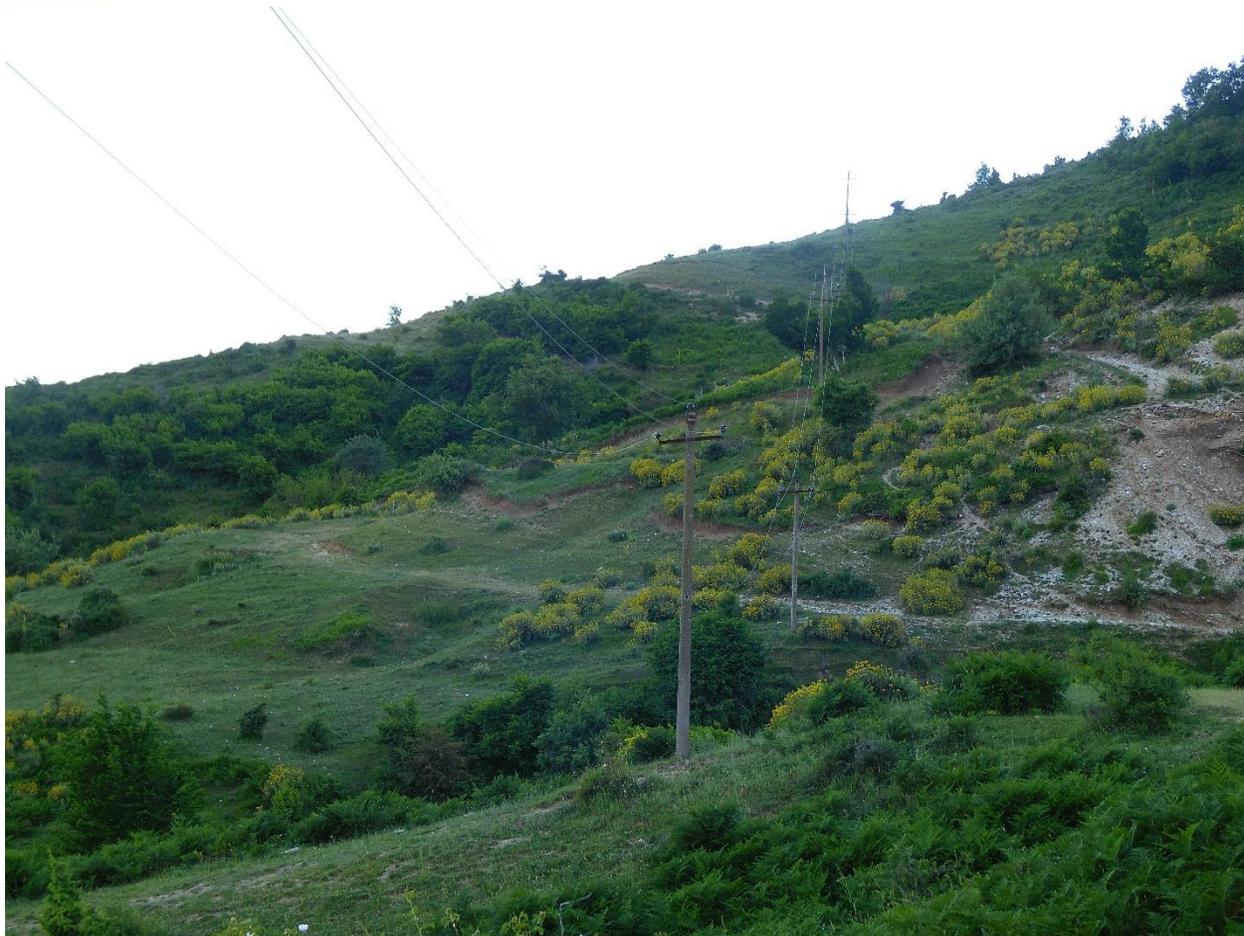
Figure 6: Power line transect situated open area.
